F131-11 Vanshack and Flame Spray

### **Metallisation Equipment Repairs Body Panels**

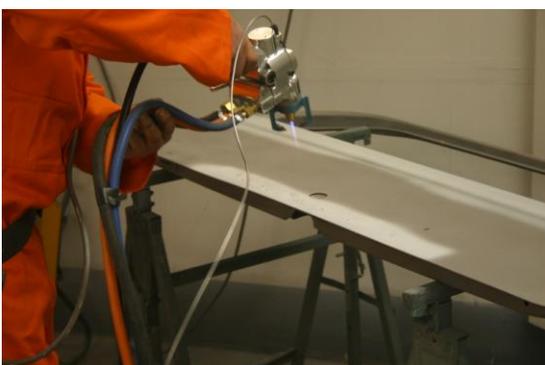
In the Flamespray process a wire is fed by a driven roller system through the centre of an oxygen-fuel gas flame where it is melted. An annular air nozzle then applies a jet of high-pressure air, which atomises and projects the molten material, in this case zinc, onto the vehicle panel surface.

For Vanshack, Flamespraying zinc onto a peppered body panel is a revolutionary way of restoring and protecting original panels, to 'conserve the original'. Traditional methods would mean the damage would have to be cut out and replaced but now, using metal spraying, zinc is sprayed over the exposed perforations, replacing what has been lost. In some

cases, where the holes are quite large, a support panel or tape is applied behind the open holes to aid the build up of zinc. The zinc will not bond to the support panel or tape, which is simply removed after the repair is complete. The Vanshack Team refers to this as Flame Repair.
